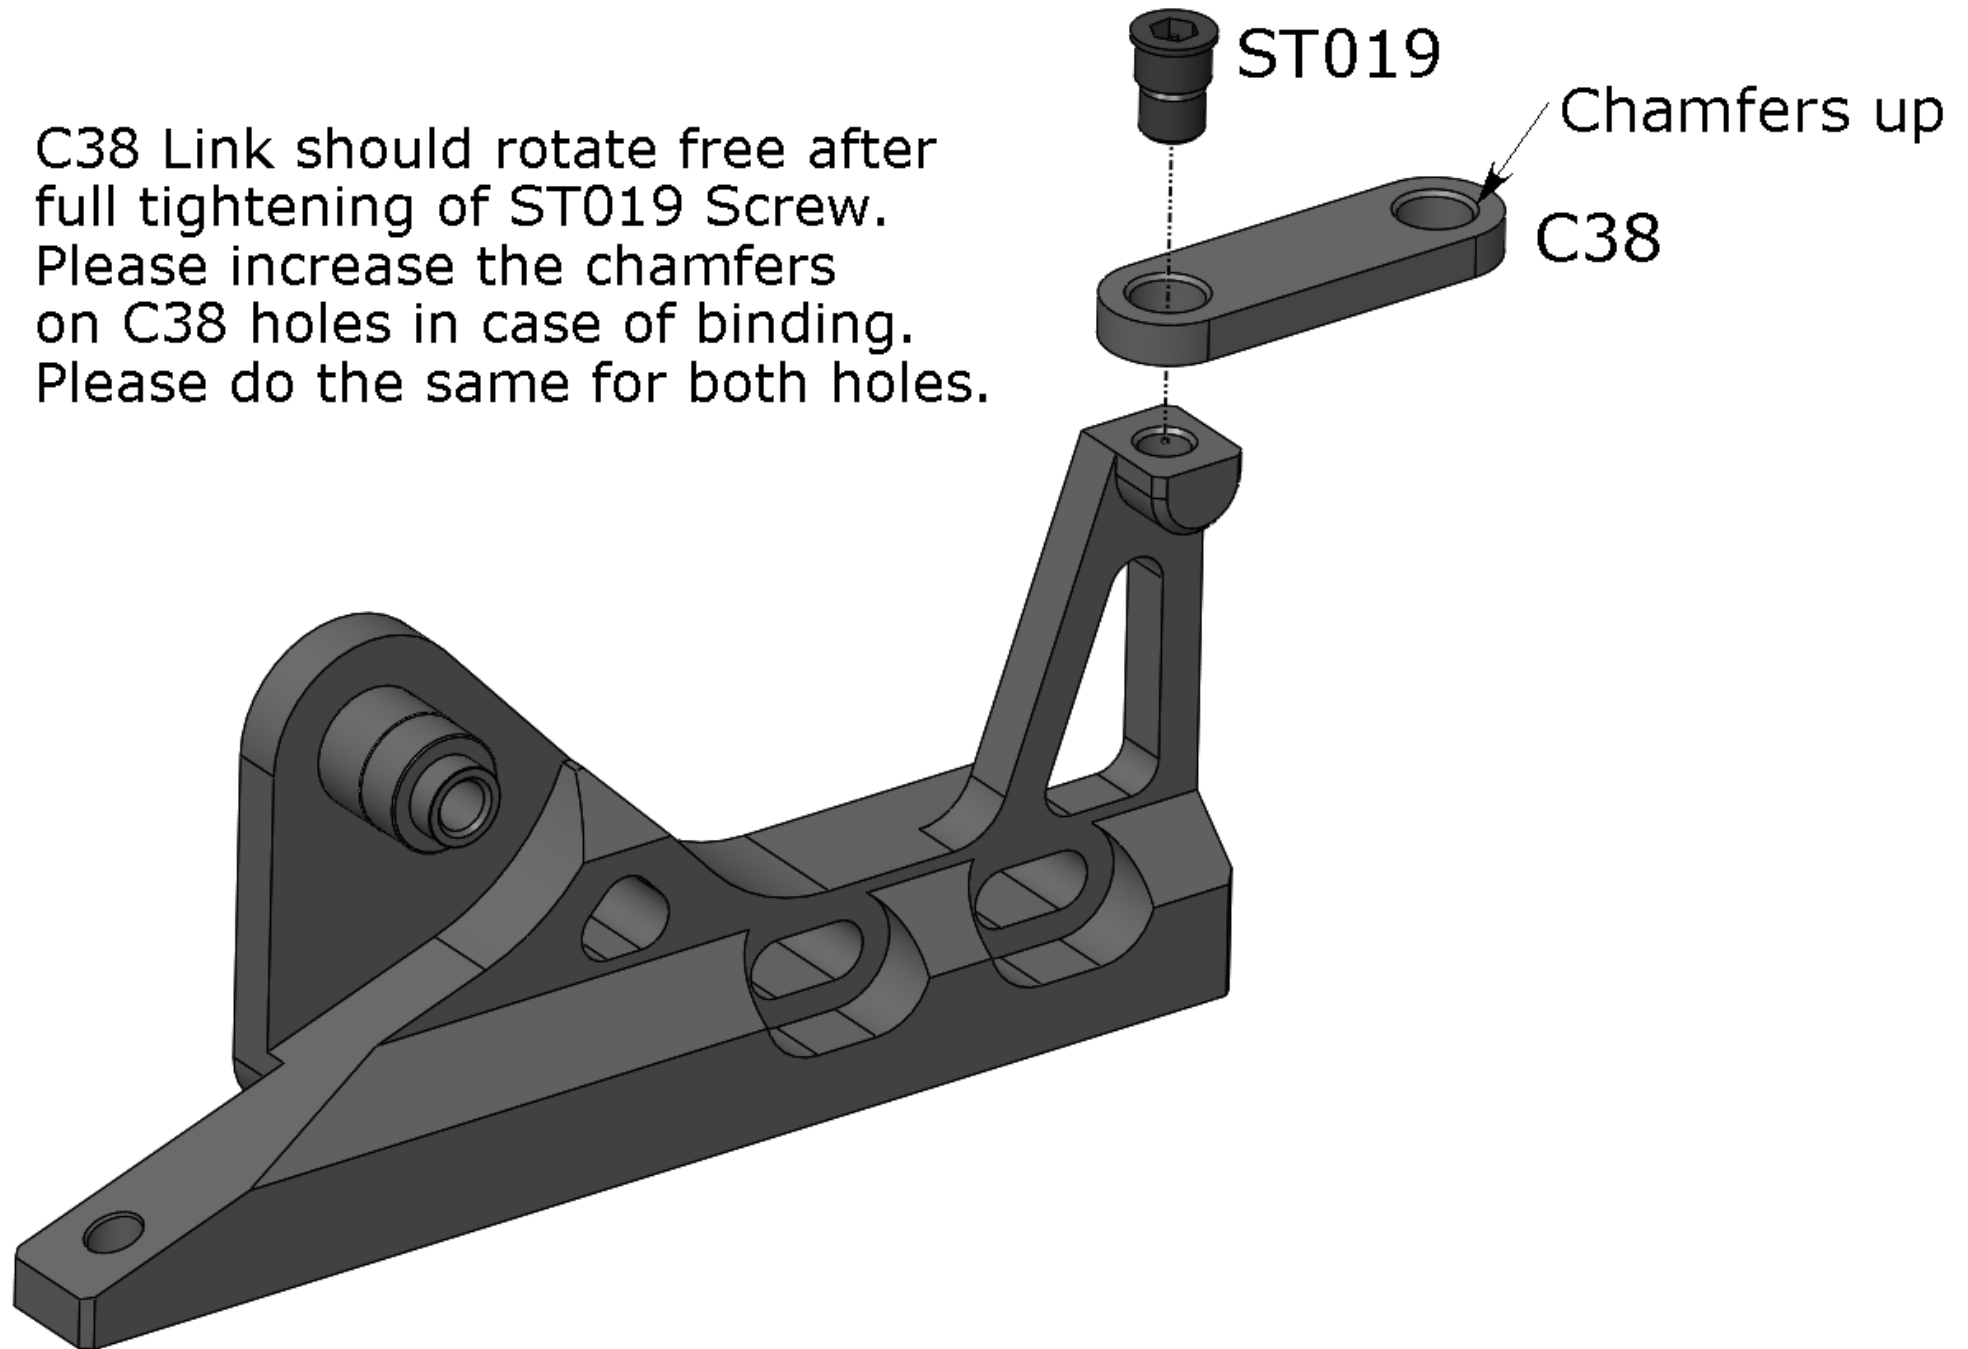
C38 Link should rotate free after full tightening of ST019 Screw. Please increase the chamfers on C38 holes in case of binding. Please do the same for both holes.
