AWESOMATIX AT78-OR152S MANUAL

Introduction.

- . AT78/OR152 combination replaces P45L sponge piston in D2.2 damper.
- . It will allow better volume compensation than P45L sponge piston.
- . Even smoother operation of D2.2 damper at any conditions.

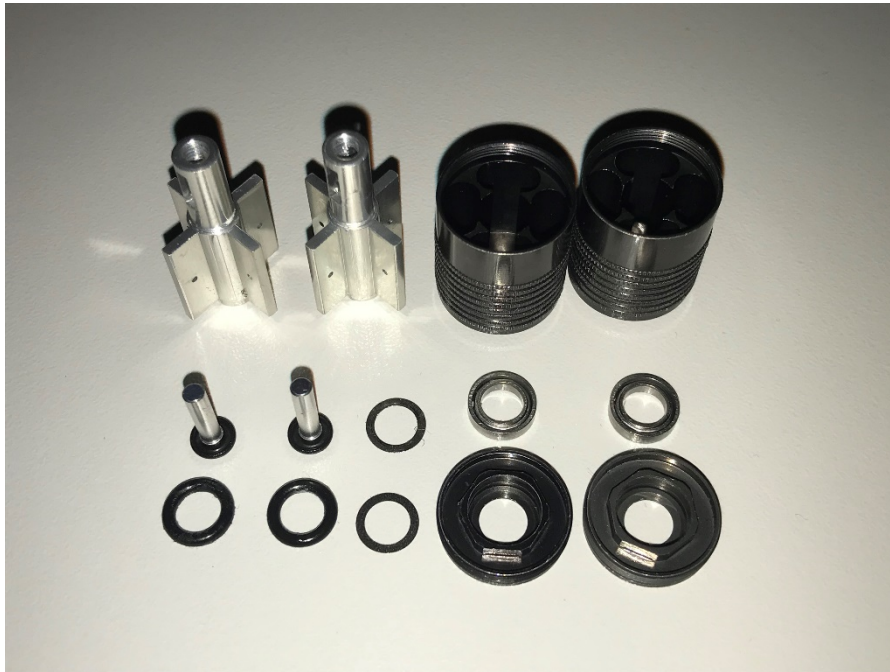
1. Open D2.2 damper and clean all parts properly. Take care on all O-Rings! They shouldn't get any contact with brake cleaner, otherwise they will be destroyed.
2. Put OR152S carefully onto AT78 shaft. Open side or the "U-Ring" faced upwards.

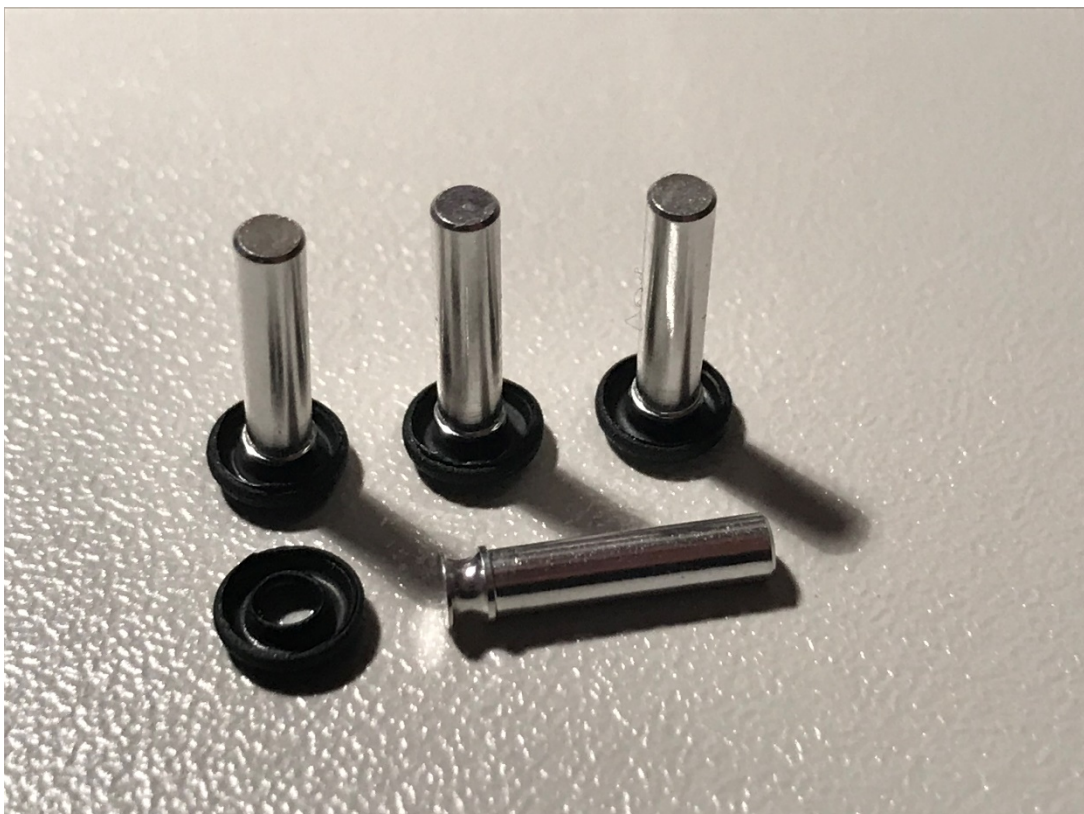
3. Apply some silicon oil on outer edges of OR152S to allow free movement inside Damper Vane. Take care to not put silicon oil into top face of the rings.

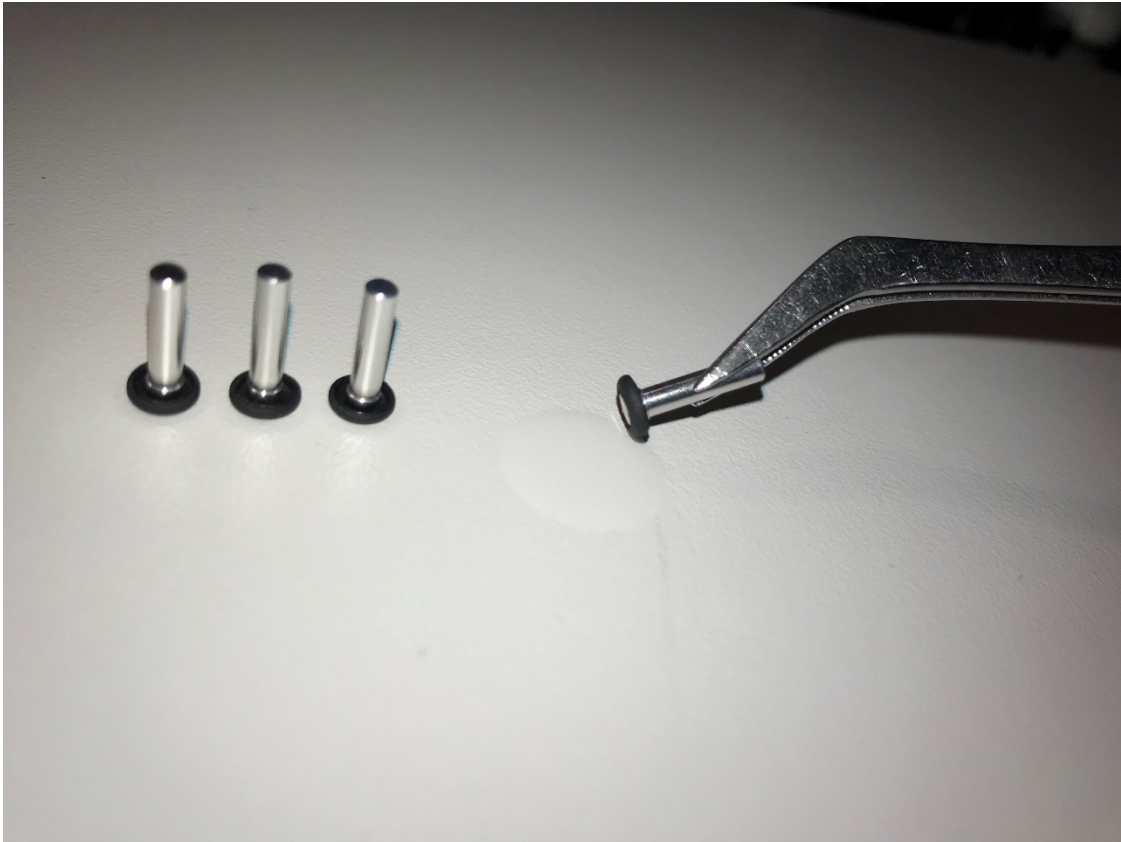
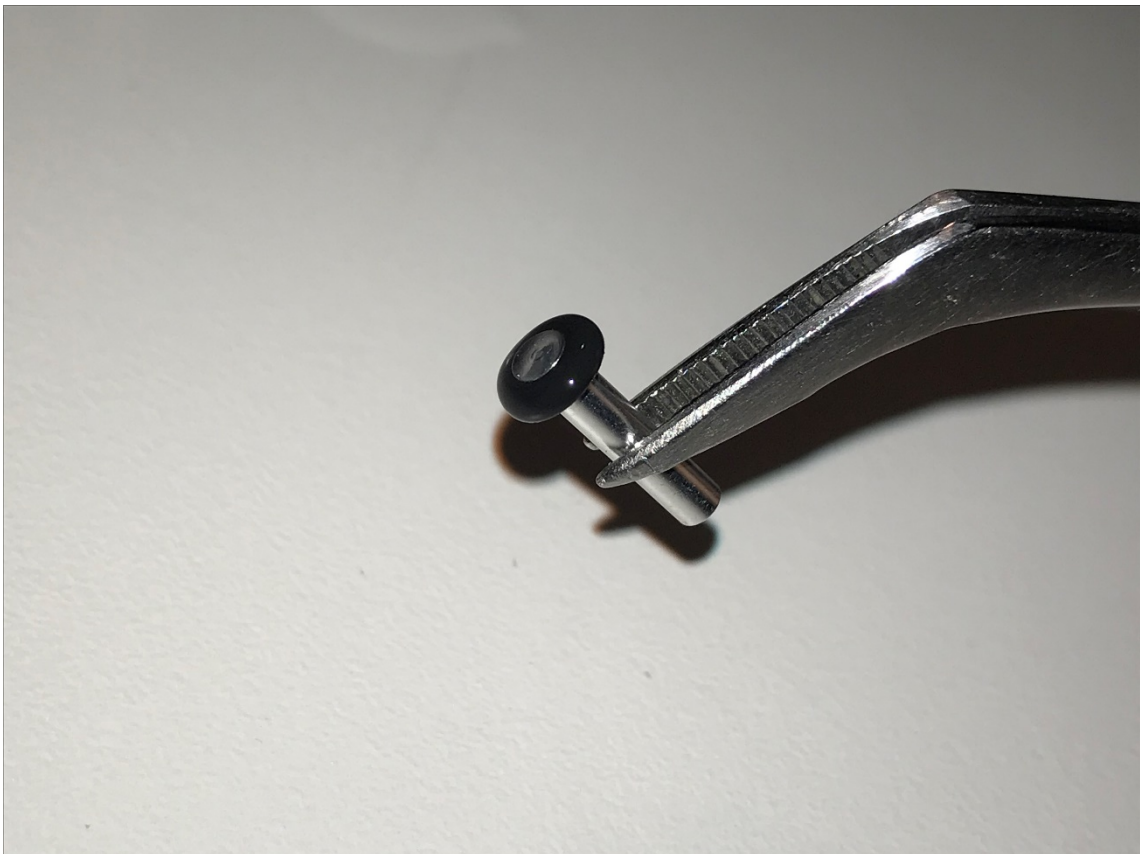
4. Put AT78 with OR152S from lower side into Damper Vane. Take care of orientation or the U-Ring. Do this slow and carefully. Make sure edges of U-Ring isn't flipped backwards. Don't push AT78 piston to far inside. It should be level with lower surface of Damper Vane.

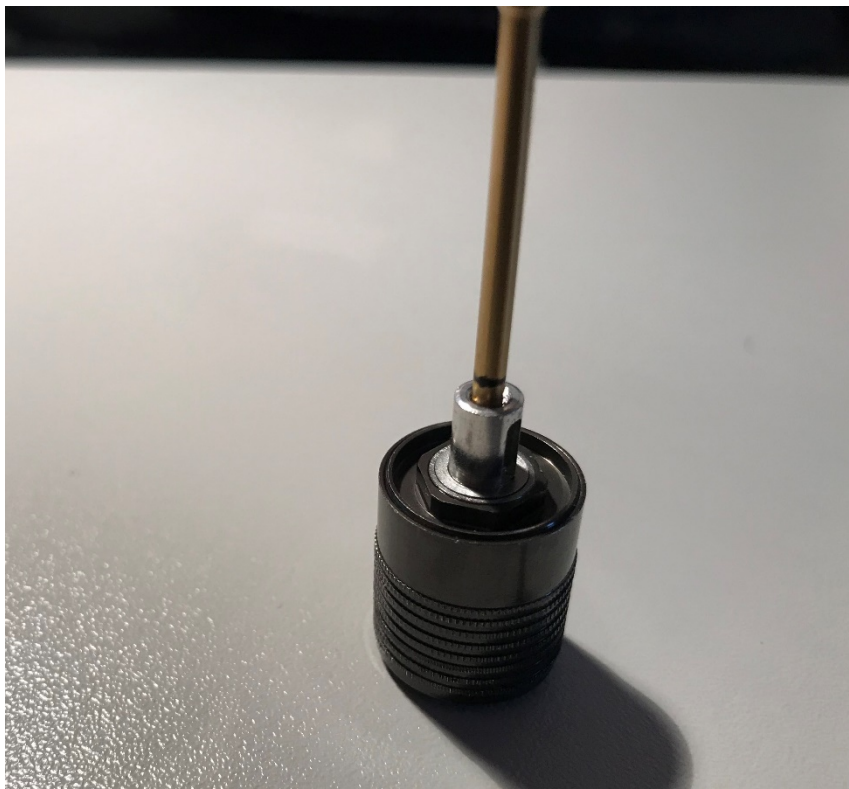
6. Assemble Dampers like shown in instruction manual. **IMPORTANT**, don't push Damper Vane into the Damper housing. Let the Vane sink into oil from own weight. Otherwise AT78 can be moved upwards.
7. During closing the Damper, the pressure will move the AT78 piston 1-2,5mm upwards. This can be proved with the marked probe tool. **IMPORTANT** be careful at this stage, don't push AT78 piston down with your probe tool, otherwise OR152S can be deformed and leak oil!
