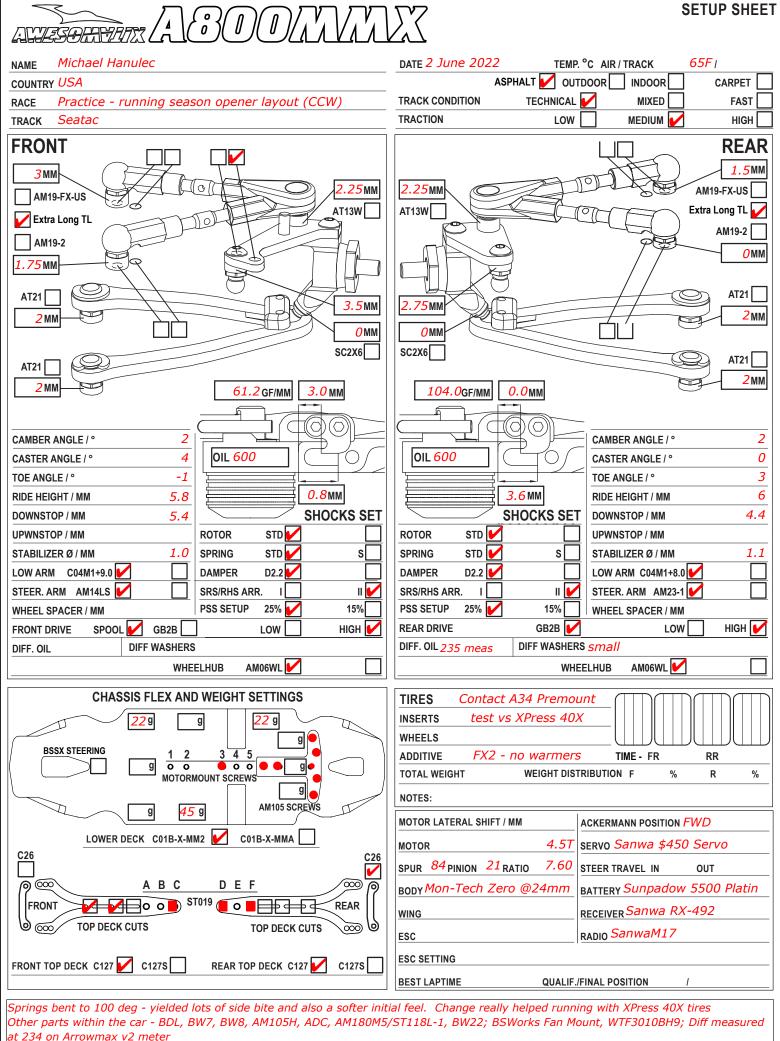
Next time: move rear to type 1 and bgap = 3.2 (lower value due to 100 deg bent hard springs); try more steering bumpshims; adjusting AM06 shimming; testing +/- 1mm front lower arm shim; low diff & spool; FBS in Front Rear along with baseline test raising uppper links to 3.5mm total height (adding 1.75mm); retesting chassis flex with top decks / rear C26 / AM105H; ESC software tests
