## **E4RS II EVO - Tip 14: Rear Upright Fixation Screw**

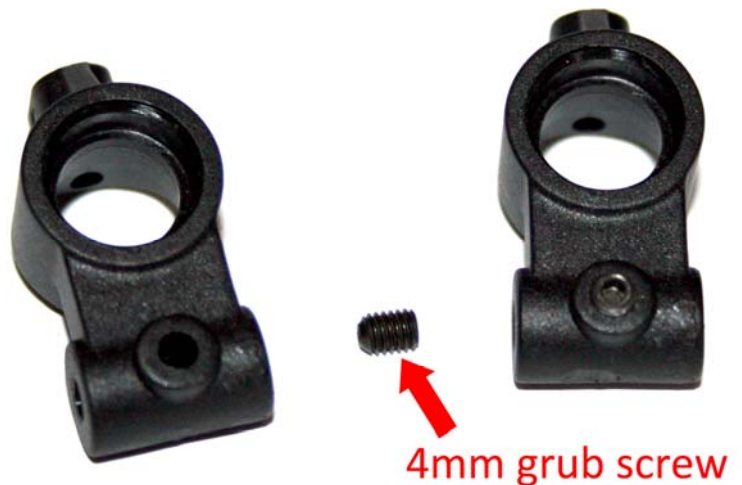
Many drivers have already been frustrated by a rear upright fixation hole damaged by a overtighten grub screw.

A very easy way to avoid this problem is simply to replace the 3mm grub screw by a longer one (4mm).

I'm very satisfied by this easy modification; as I never got any defective rear upright since I changed the 3mm grub screw by a 4mm one (TM126304S).
